# SPEARHEAD HOME INSPECTORS

# PROPERTY INSPECTION REPORT FORM

1111 Beautiful st. , Corpus Christi, TX 78415

10/31/2024 12:00 pm

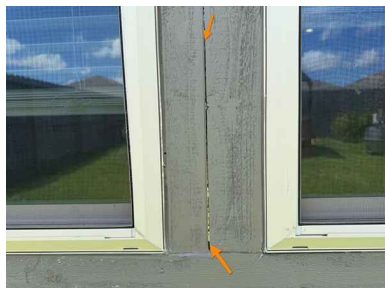
Several locations

**1: Caulking - Window Trim**

Caulking around widow trim was old, discolored, cracked or missing, and needed maintenance to avoid potential moisture intrusion. Moisture intrusion can lead to serious structural damage. Recommend a qualified handyman install caulking at all needed areas of window trim.

Recommendation: Contact a handyman or DIY project

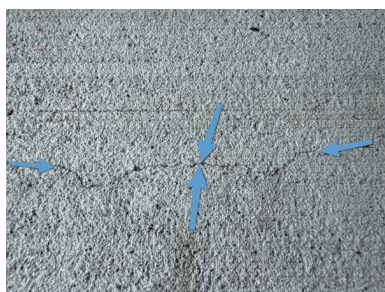
Back Porch

#### 1: Concrete Porch Cracks - Cosmetic

There were small cracks observed in the concrete porch. These were minor cracks which naturally occur as the concrete cures. This is considered a cosmetic item. The homeowner may choose to have repairs performed for aesthetic purposes.

Recommendation: Recommend monitoring.

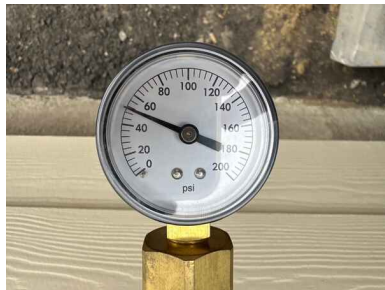
*Static Water Pressure Reading:* 50 PSI (Pounds Per Square Inch) -

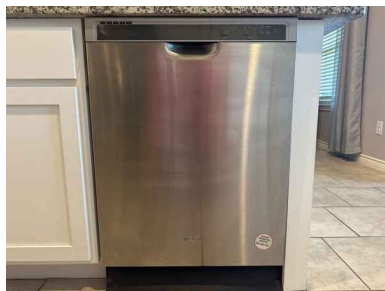
#### 1: Heating Element Damaged or Missing

The heating element located inside the dishwasher is damaged and is no longer operable. I recommend the old heating element be replaced. The process generally involves disconnecting the dishwasher's power, removing the old element, and installing the new one.

Recommendation: Contact a qualified appliance repair professional.

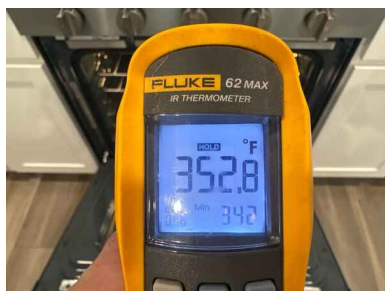
*Measured Temperature:* 352.8 Degrees Fahrenheit -

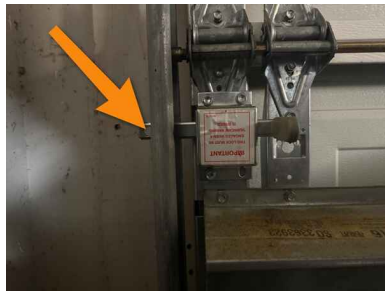
**1: Manual Locks In Place**

There were manual door locks or latches were present on operator controlled doors. It is recommended that the manual door locks be removed or disabled when automatic door controls are in use to avoid damage. If the lock is engaged when the operational button for the garage door is pressed, severe damage to the door can occur. Recommend disabling the manual locks when a garage door operator is present. The simplest way to do this is to place a bolt through the hole in the latch.

Recommendation: Contact a handyman or DIY project
